## Did you **know** ...

... that “In-ground” hydraulic jacks built before 1972 contains an additional risk for passengers compared to more modern designs?

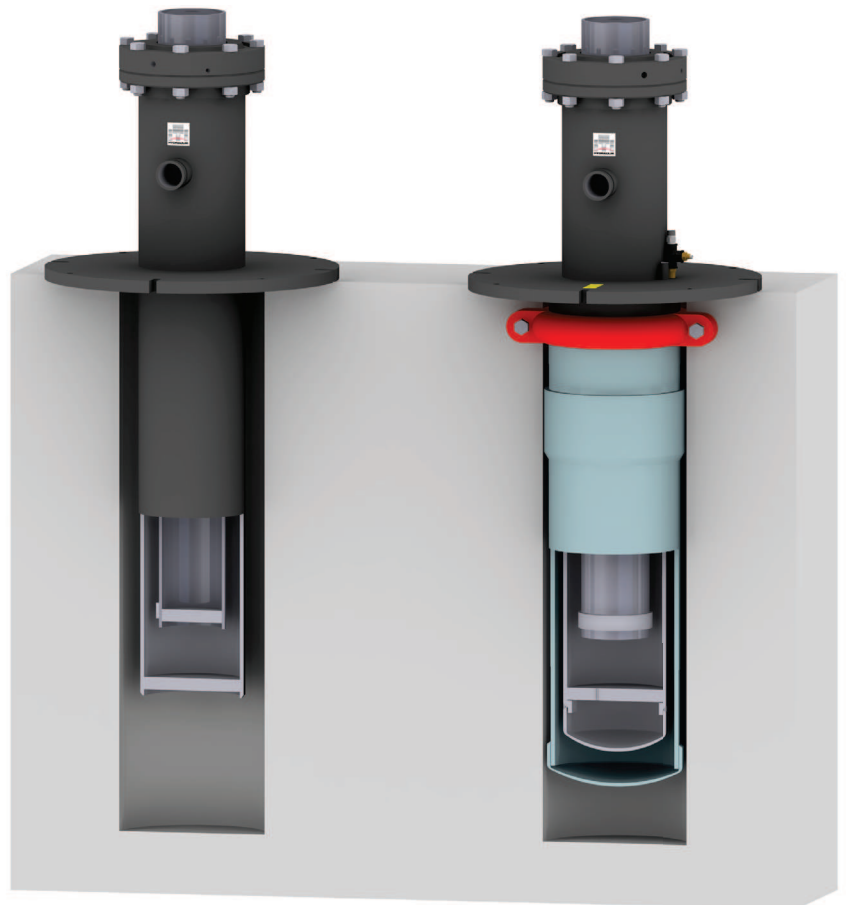
Indeed, over time, rust will tackle the housing and may cause some serious damage to the weld seam between the housing and the welding cap. Should a major hole in the cap appear, there would be a sudden loss of pressure which would lead to the downfall of the booth, likely to cause serious injury or even death of passengers.

For this reason, the Canadian code for Elevators (CSA B44, 3.18.3.4 – Safety Bulkhead) requires that “cylinders buried in the ground shall be provided with a safety bulkhead having an orifice” that can control the leakage and thus ensure a safe route for the occupants of the cabin.

Thus, the research team and development of ITI Hydraulik, has introduced a device capable of preventing such disasters. Thus, the “double bottom” was born. The “double bottom” end of the housing is perforated to control the flow of oil in the event that the welding cap can no longer adequately contain the hydraulic fluid.

Although this solution provides a safe mechanism for the passengers, this design does not regulate the environmental aspects of such failure. Thus the PVC oil recovery sheath (optional) emerged. This added feature will prevent an oil spill in the ground, in addition to protecting the exterior of the casing against corrosion.
